# **PRESENTATION ON CASE STUDY OF LIGHTING IN BANDIPUR AND POKHARA**

**Presented By:** Sunita Koju  
Usha Adhikari  
Avinash Chaudhary  
Rajan Shah

**Presented To:** Diwakar Bista  
Assistant Professor  
Electrical Department  
Kathmandu University

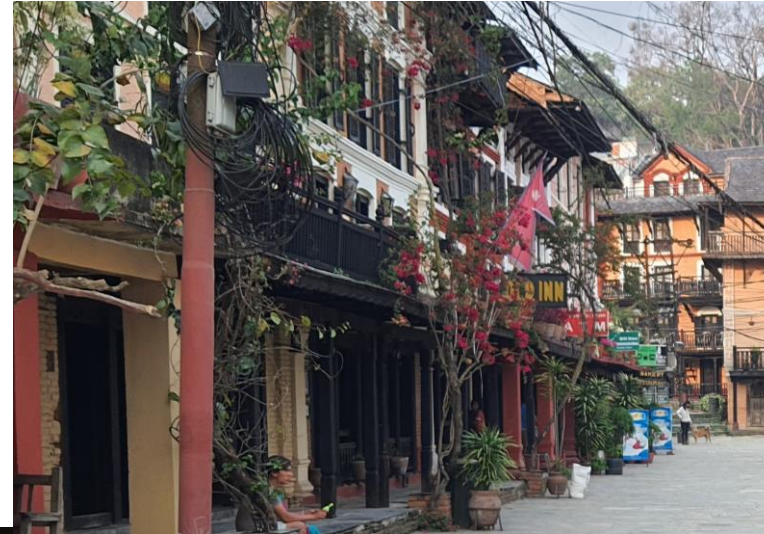
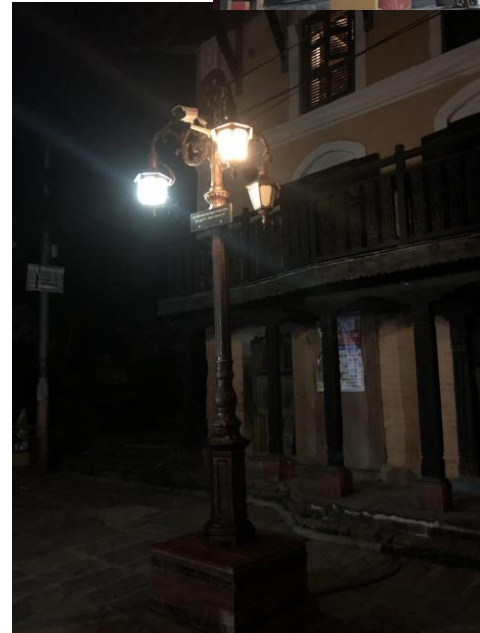
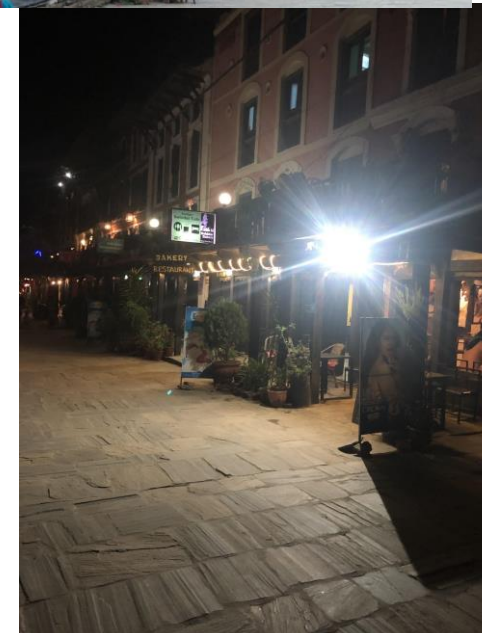
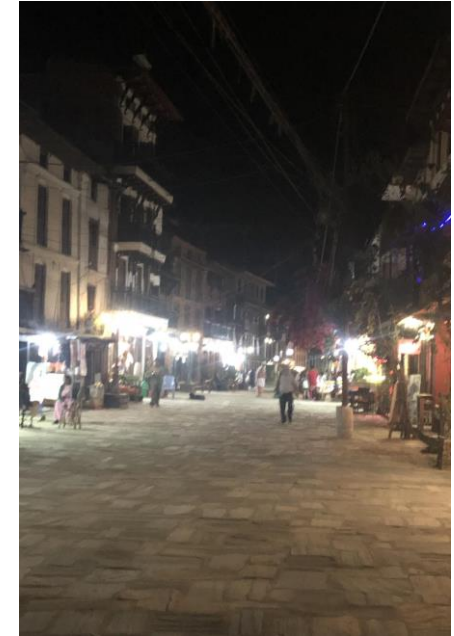
## 1. Main Street

- Illuminance:
  - a.  $E_{\text{horizontal}} = 10.878 \text{ lux}$
  - b.  $E_{\text{vertical}} = 13.45 \text{ lux}$
  - c.  $E_{\text{max}} = 17.11 \text{ lux}$
- No provision for the emergency lighting
- Poor maintenance
- Mix of warm and cool light in single post.

- Unmanaged wiring degrading the scene shall be made underground. Local government shall take the initiative
- Some sort of lighting schemes shall be followed so that there will be uniformity in lighting distribution.
- For the timely and proper maintenance of the lights, team shall be developed in collaborations of the local government and the locals themselves.
- For the temples and other heritages specialized lighting schemes need to be implemented.
- Solar lights shall be installed at certain intervals so that it can act as the back up lights when there is cut off in NEA line.
- Not only the main street but other neighbors area shall also be illuminated like way to the main street, tindhare which carries the cultural and historic importance. This will help attract the tourist to those areas.

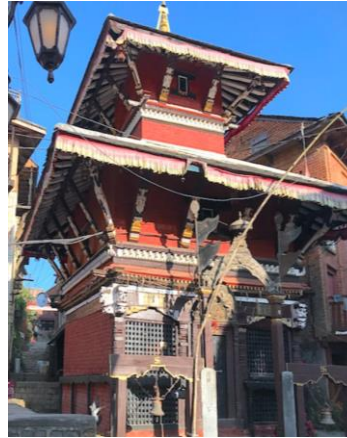
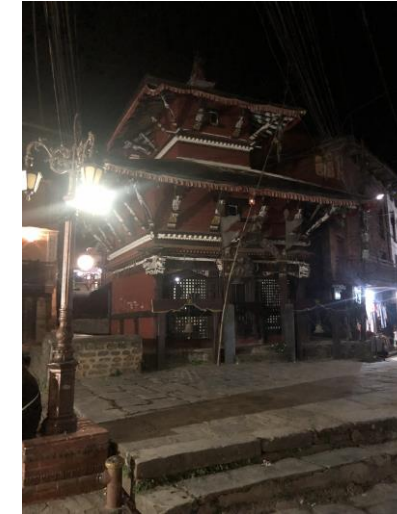
## 2. Bindabasini Mai Temple

- Illuminance:
  - a.  $E_{\text{horizontal}} = 0.43 \text{ lux}$
  - b.  $E_{\text{vertical}} = 4.9 \text{ lux}$
  - c.  $E_{\text{max}} = 4.9 \text{ lux}$

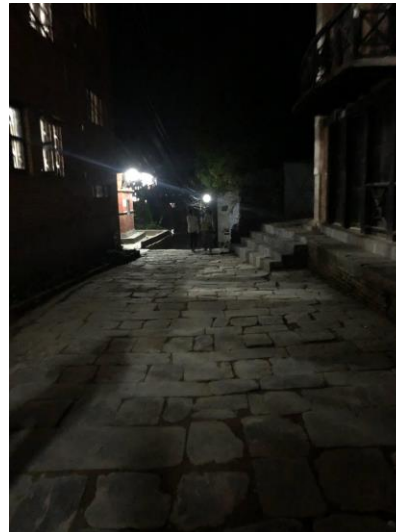
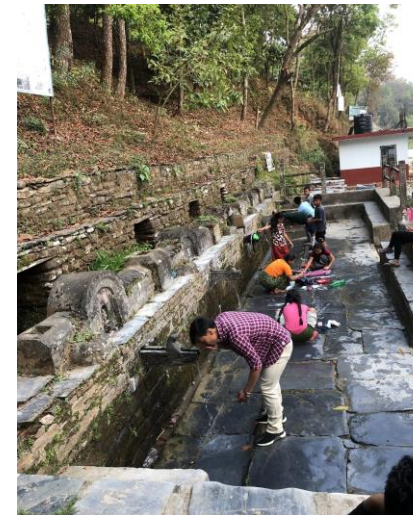
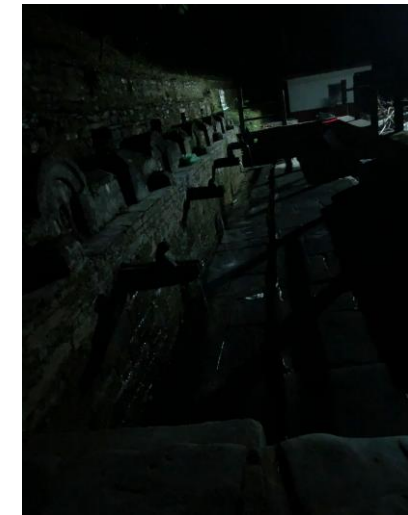
## 3. Alley to Tindhare

- Illuminance:
  - a.  $E_{\text{horizontal}} = 3.347 \text{ lux}$
  - b.  $E_{\text{vertical}} = 2.36 \text{ lux}$
  - c.  $E_{\text{max}} = 4.2 \text{ lux}$

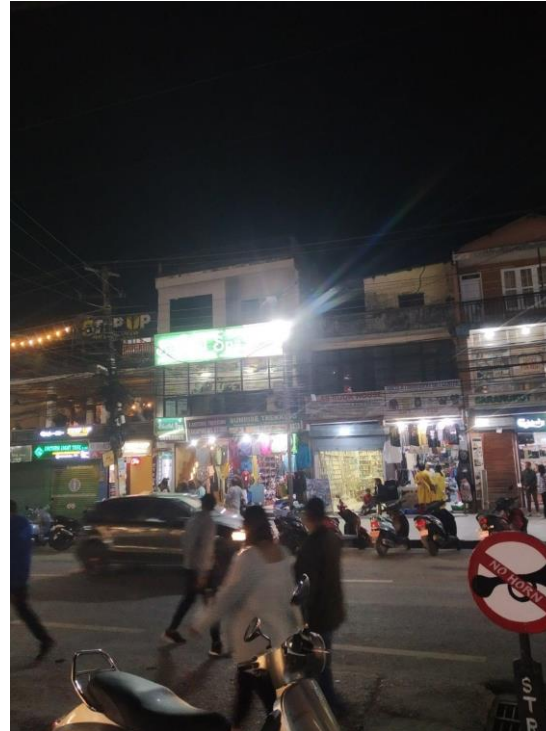
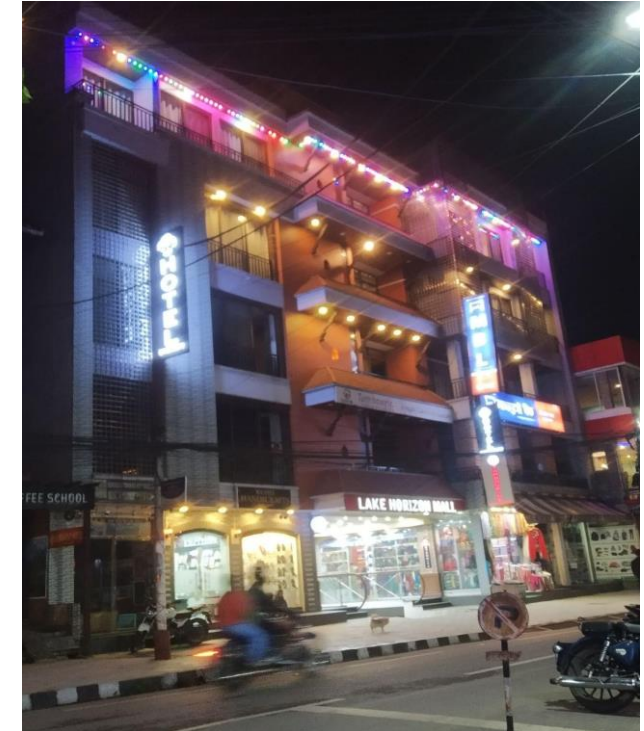
## 1. Main Street:

- Illuminance:

a.  $E_{\text{horizontal}} = 19 \text{ lux}$

b.  $E_{\text{vertical}} = 23.5 \text{ lux}$

c.  $E_{\text{max}} = 24.2 \text{ lux}$

- No provision for the emergency lighting
- No proper maintenance
- Not enough light in the main road after the shutdown of all shops and local business during night time.

- To avoid the improper lighting by the local businesses there should be regulations regarding the lighting so that the natural environment at lake side would not be disturbed.
- Not only installation but maintenance shall also be taken care by the local authorities.
- Street lighting should be done with adequate span and durable LED lamps of enough brightness.
- Enough public lights shall be provided so that haphazard light installation by the locals can be controlled.
- Waterproof (IP65 or above) lights should be used at places such as cave where problem of water dripping is prevalent.
- Warm lights and spotlights shall be used where the stone's gradient can be observed.
- Caves should be illuminated with low illuminance (low brightness) lights.

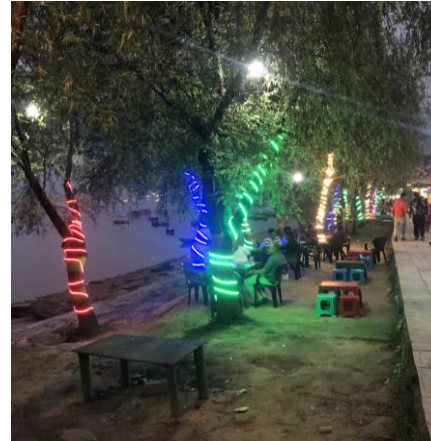
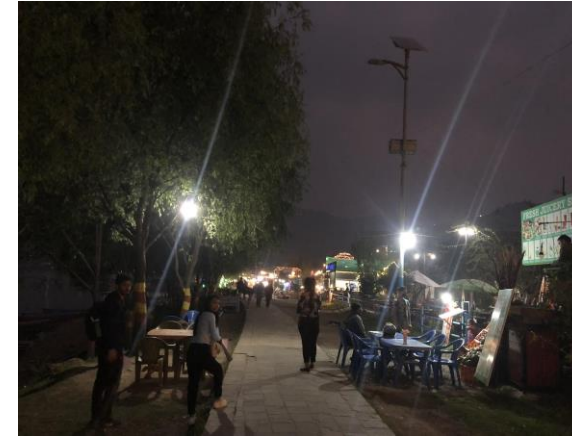
## 2. Lake Side

- Illuminance:
  - a.  $E_{\text{horizontal}} = 14.3 \text{ lux}$
  - b.  $E_{\text{vertical}} = 13 \text{ lux}$
  - c.  $E_{\text{max}} = 13.2 \text{ lux}$

Street lights were placed at gaps of 25 to 30m.

Very Poor maintenance

Uncomfortable feeling due to  
extravagant lights

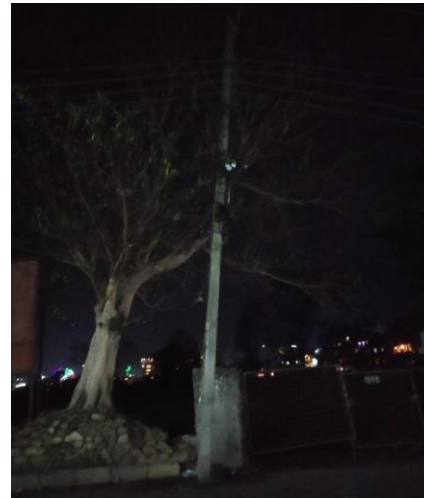
## 3. Street 17

- Illuminance:
  - a.  $E_{\text{horizontal}} = 9.3 \text{ lux}$
  - b.  $E_{text{vertical}} = 8.7 \text{ lux}$
  - c.  $E_{\text{max}} = 9.1 \text{ lux}$

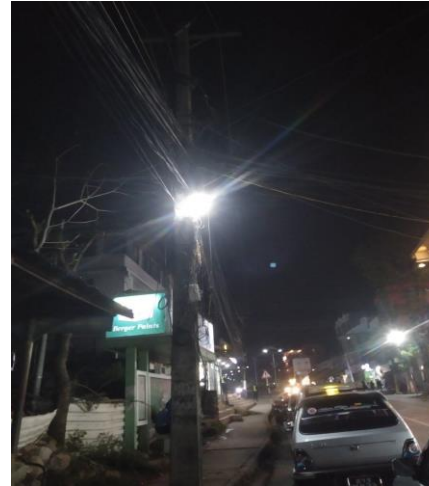
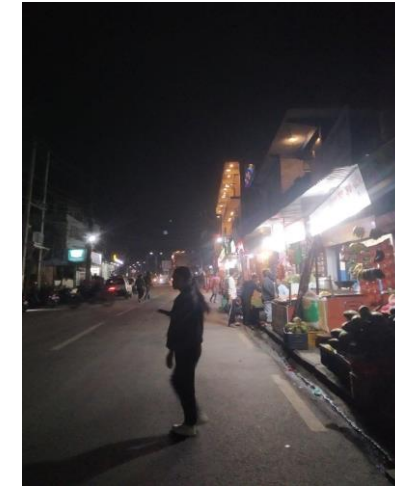
## 4. Street to lake side from Hallanchwok

- Illuminance:
  - a.  $E_{\text{horizontal}} = 8.9 \text{ lux}$
  - b.  $E_{\text{vertical}} = 8.1 \text{ lux}$
  - c.  $E_{\text{max}} = 8.4 \text{ lux}$
- Poor maintenance
- Not enough light after the shutdown of all shops and local business during night time.
- Very poor lighting

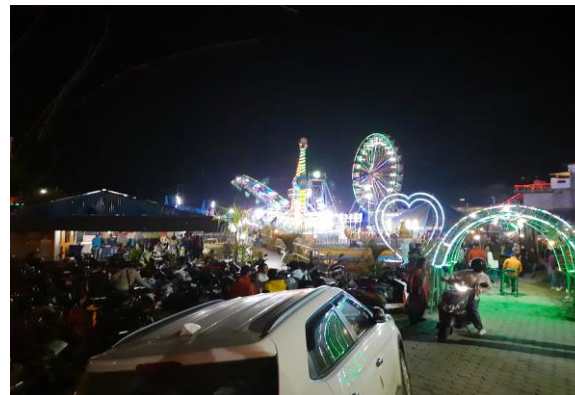
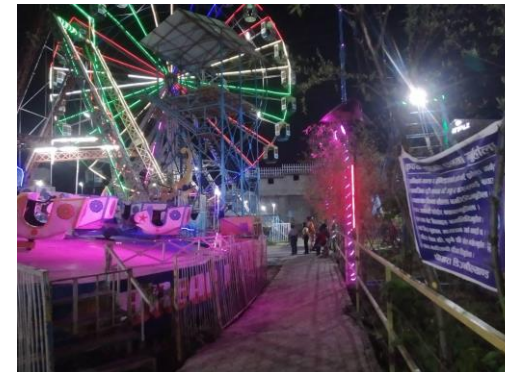
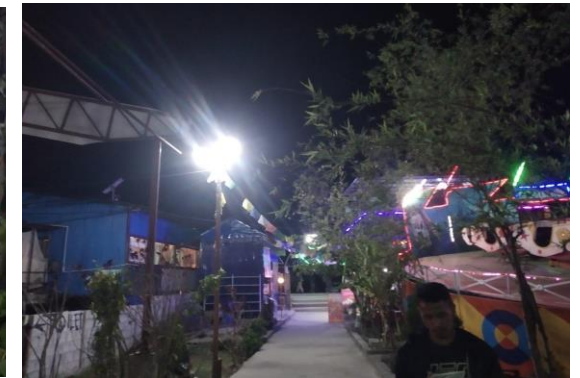
## 5. Disney land

- Illuminance:
  - a.  $E_{\text{horizontal}} = 15.8 \text{ lux}$
  - b.  $E_{text{vertical}} = 19.2 \text{ lux}$
  - c.  $E_{\text{max}} = 19.1 \text{ lux}$

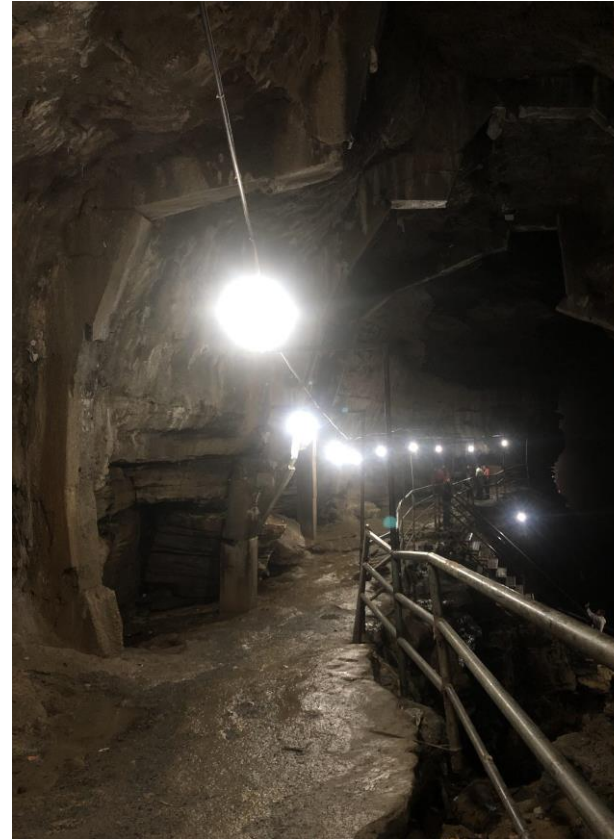
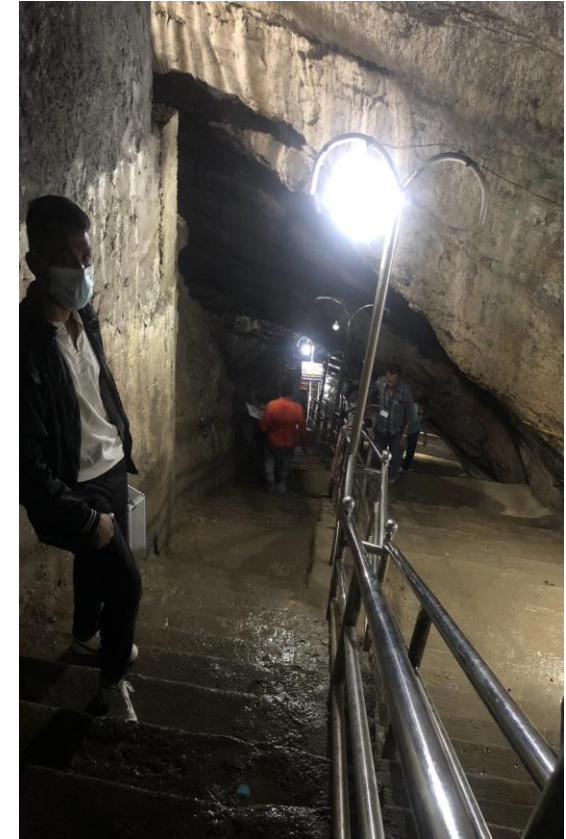
## 6. Gupteswor Gufa

- Illuminance:
  - a.  $E_{\text{horizontal}} = 15.6 \text{ lux}$
  - b.  $E_{\text{vertical}} = 17 \text{ lux}$
  - c.  $E_{\text{max}} = 17 \text{ lux}$
- Site was moist and water was dripping.
- Cool LED light bulbs were used.
- Wiring was unmanaged leading to risk of short circuit, 220 V ac system was used.
- Mounting height of the lighting fixtures was low.
- Lighting installations produced glare at a lot of points disturbing the visibility.
- Poor maintenance was seen as few bulbs were flickering.
